Technical Memorandum

Re: Polynesian Isle Boulevard at Barefoot Path Memorandum

Introduction

Field Observations

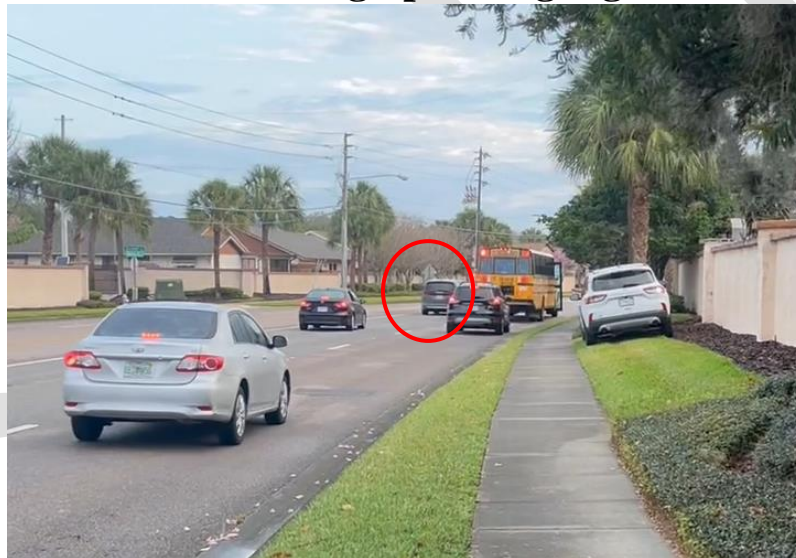
On numerous occasions, vehicles were observed driving around stopped school buses (with red flashing lights and stop arms activated) during student pick-up and drop-off activities, as shown in Figures 2 and 3. This is a direct violation of Florida Statute 316.172. These traffic infractions were observed northbound and southbound along Polynesian Isle Boulevard. In some instances, multiple vehicles were observed passing the stopped school buses. School buses observed during the field review were in compliance with Florida Statute 316.172.3. and were entirely visible for a distance of 200 feet in either direction.

Figure 2 – Vehicle Passing Stopped School Bus

1. Install two (2) new SCHOOL BUS STOP AHEAD (S3-1) sign assemblies on Polynesian Isle Boulevard as shown in the Improvements Diagram (Appendix C). This improvement is intended to reduce the number of motorists driving past stopped school buses.

9. Coordinate with the Osceola County School District to determine the feasibility of relocating the school bus pick-up and drop-off operations away from Polynesian Isle Boulevard to the intersections of Barefoot Path and Pinto Drive and Barefoot Path and Bear Path. This will eliminate students from crossing Polynesian Isle Boulevard. Should the Osceola County School District move the school bus pick-up and drop-off locations to the recommended intersections, the installation of SCHOOL BUS STOP AHEAD (S3-1) signs on Polynesian Isle Boulevard would not be necessary.

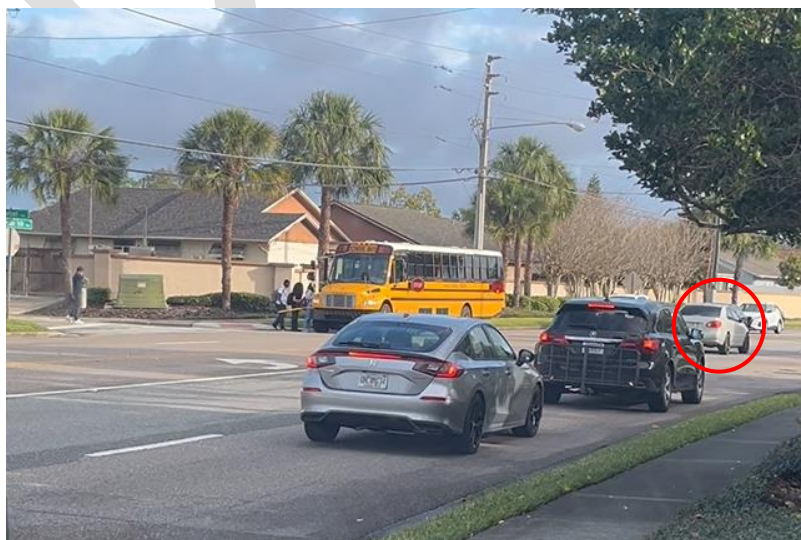
Figure 3 – Vehicle Passing Stopped School Bus

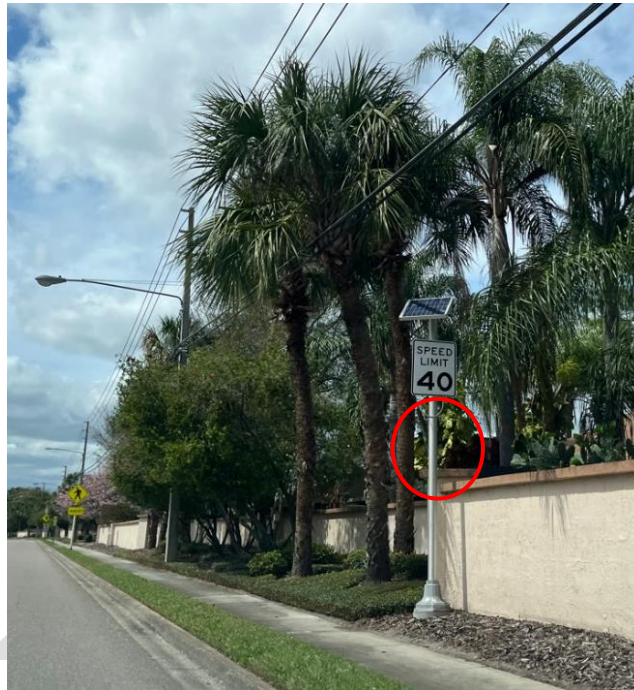
Two (2) “YOUR SPEED” sign assemblies are located along Polynesian Isle Boulevard. One (1) is located 1,650-feet north of Barefoot Path for southbound traffic and the other is located 305-feet south of Barefoot Path serving northbound traffic. The sign assembly for the southbound direction is missing the “YOUR SPEED” sign and overhanging leaves from nearby palm trees partially obstruct the solar panel, as shown in Figure 4. In addition, the “YOUR SPEED” sign in the northbound direction was inoperational, as shown in Figure 5.

Figure 4 – Missing “YOUR SPEED” Sign - SB Direction

2. On southbound Polynesian Isle Boulevard, install a new sign assembly encompassing an Intersection Warning (W2-1), a 30 mph Advisory Speed plaque (W13-1p), and a Your Speed Warning plaque (W13-20aP), as shown in the Improvements Diagram (Appendix C).

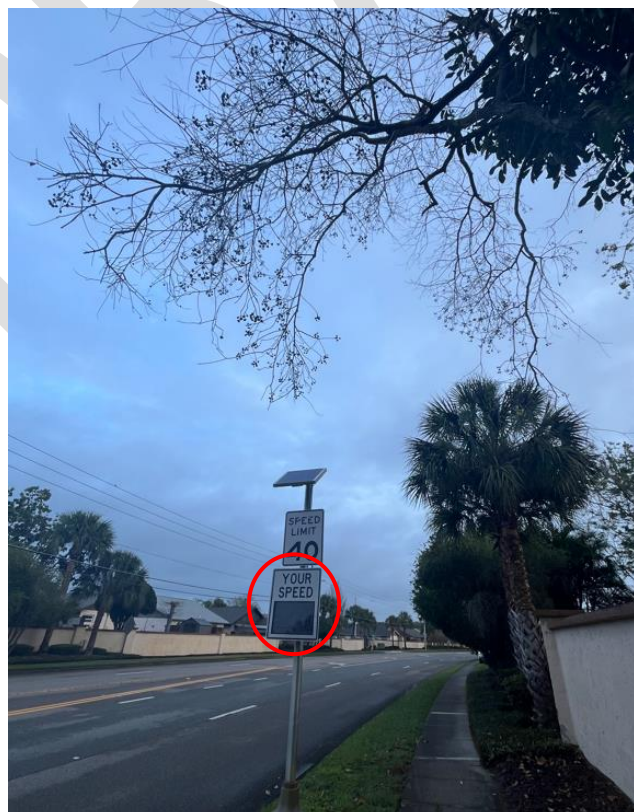
Figure 5 – Inoperational “YOUR SPEED” Sign - NB Direction

4. Remove the existing "YOUR SPEED" sign assembly on northbound Polynesian Isle Boulevard located south of the Barefoot Path intersection as shown in the Improvements Diagram (Appendix C).

5. On northbound Polynesian Isle Boulevard, relocate the existing 40 mph Speed Limit sign (R2-1), as shown in the Improvements Diagram (Appendix C).
6. On northbound Polynesian Isle Boulevard, install a new sign assembly encompassing an Intersection Warning (W2-1), a 30 mph Advisory Speed plaque (W13-1p), and a Your Speed Warning plaque (W13-20aP), as shown in the Improvements Diagram (Appendix C).

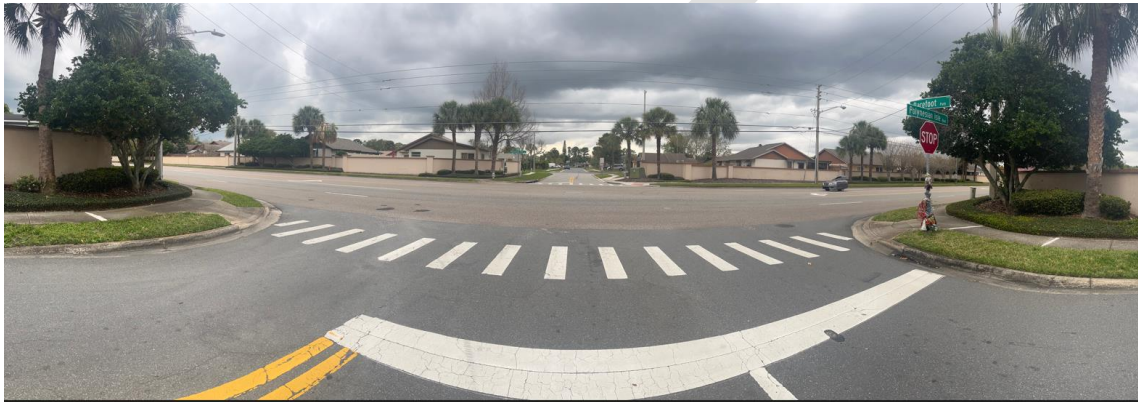
Sight distance is the length of road surface a driver can see with an acceptable level of clarity. It's crucial for safety as it allows drivers to see and react to obstacles, changes in road conditions, or another vehicle on the road. Sight distance is measured along the centerline of the road, measuring the visible distance from a driver's perspective. Reduced sight distance was observed for the westbound approach of Barefoot Path. Several near misses including rear-ends, angle collisions, and sideswipes were witnessed during the field observations. Vehicles positioned at the stop bar at this approach, have approximately 160-feet of visibility to the south and 170-feet of visibility to the north. The required sight distance per the FDOT Design Manual (FDM) is 500-feet. Sight distance increases to approximately 300-feet (to the south and the north) when motorists pull forward passed the stop bar into the crosswalk. Refer to Figure 6.

Figure 6 – Reduced Sight Distance WB Approach

8. To improve the sight distance for the westbound approach, trim the tree canopies to satisfy FDOT Florida Design Manual (FDM) Section 212.11.6 which requires there to be no part of the canopy below 8.5 feet.

10. Implement a directional median on Polynesian Isle Boulevard at Barefoot Path. This improvement will direct the westbound left turns leaving the residential development to the northernmost access point (Warrior Lane), which provides enhanced sight distance for motorists. The use of flexible delineators to create a temporary directional median (and close off the westbound left turn lane) is a cost-effective solution. The County may also consider the use of a lane separator system for additional emphasis.
